National Environment Council Meeting

NJV Rehabilitation Update

March 2013

Accelerated Rehabilitation Action Plan (RAP)

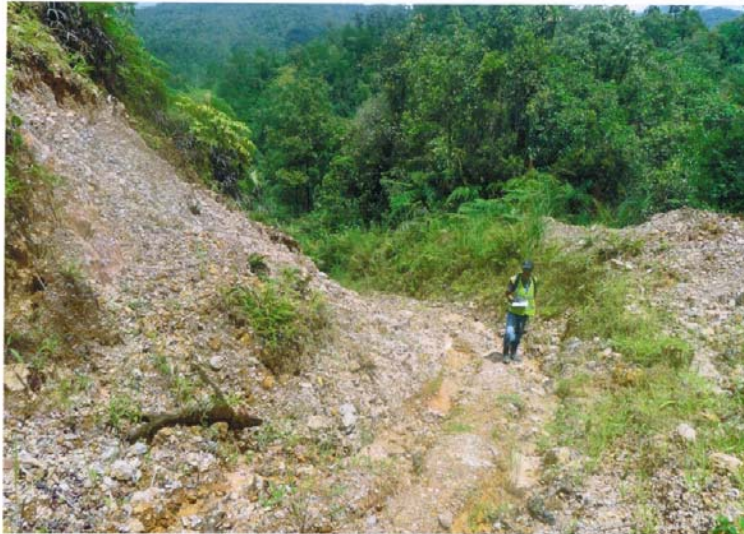
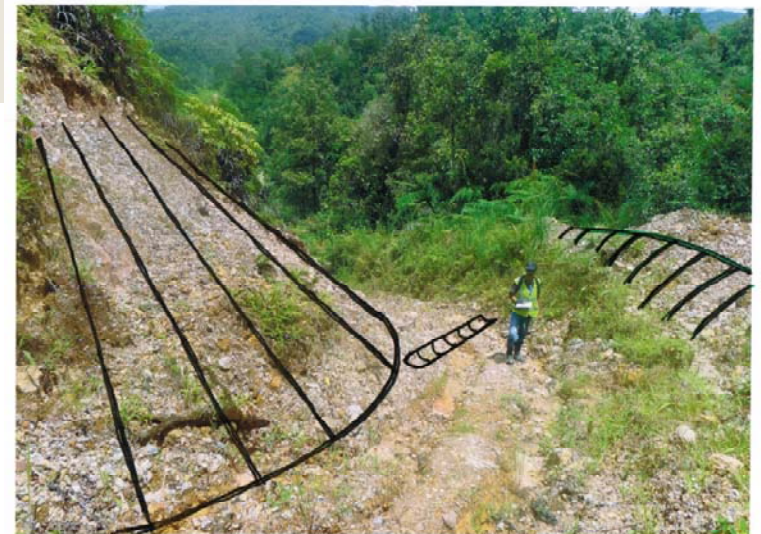
➤ Slope trimming & cut-off drains.

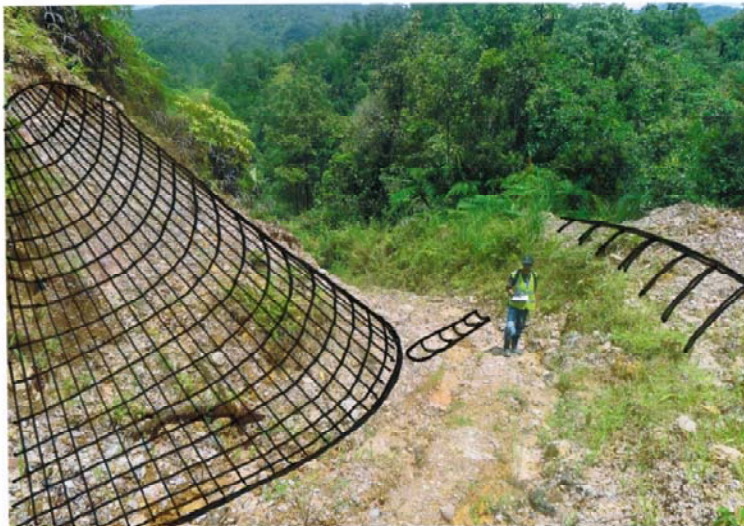
➤ Geo-textile installation.

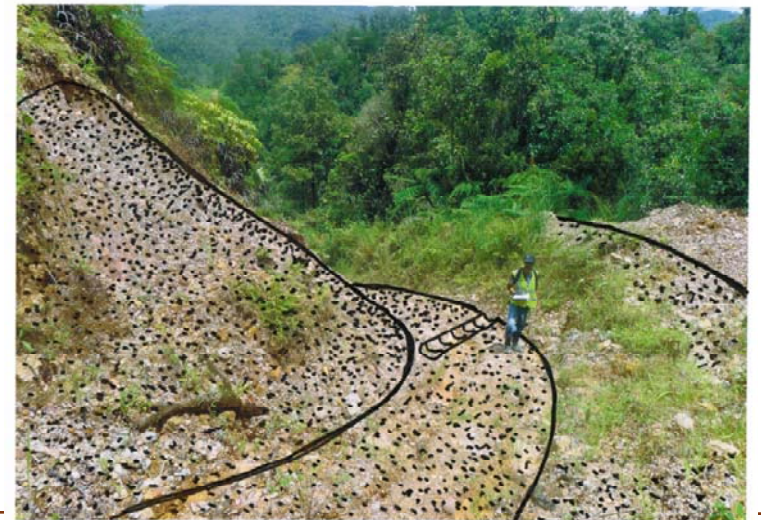
➤ Hydro-seeding.

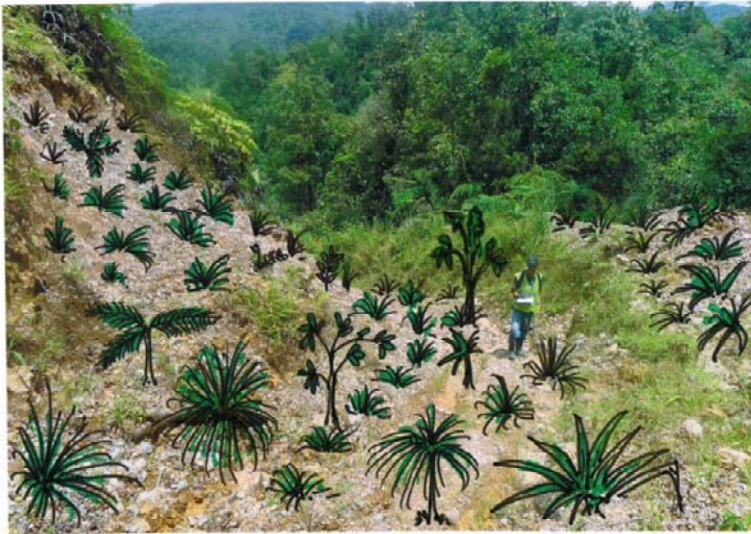
- **Planting – Trees & Ferns.**

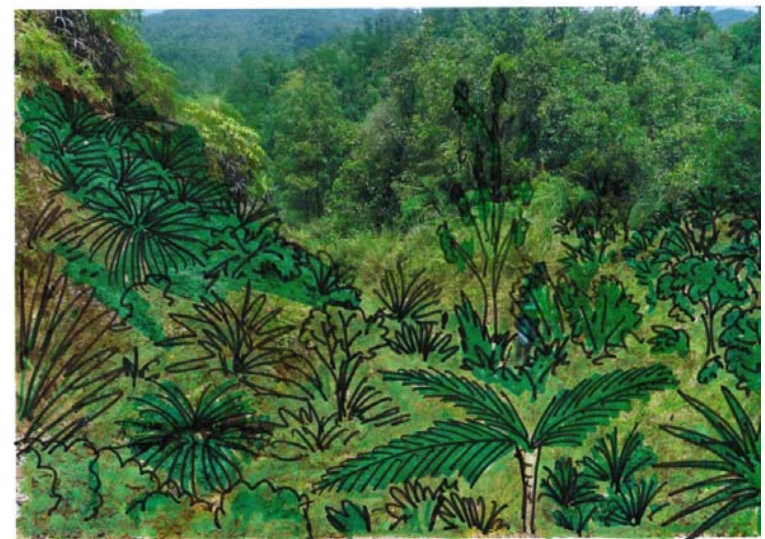
- **Fully restored habitat .**

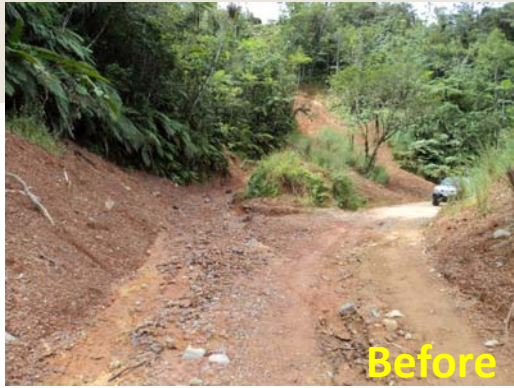
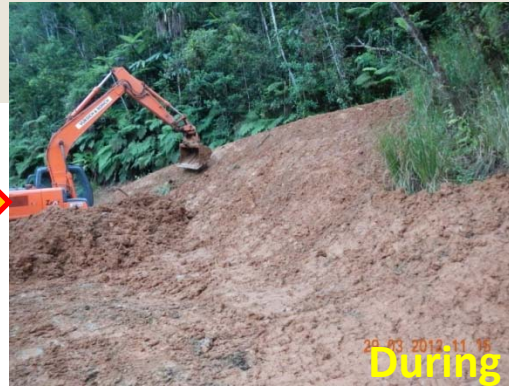
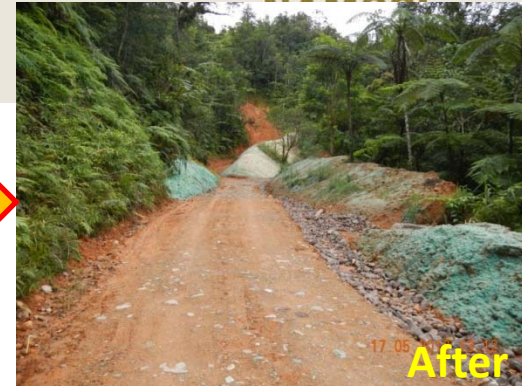
- **Phase 1 – Pilot Sites - complete:**
 - **Two Pilot Sites initially – Pilot Site 24 (Waisoi) & Pilot Site 38 (Waivaka).**
 - **To establish processes that will provide methodologies for future rehabilitation works.**
- **Additional Work Packages - complete:**
 - **Continue with the rehabilitation works – additional work packages were submitted to the Contractor.**
 - **WP1, WP2, WP3, NVD 039 & NVD 040.**
- **Completion & Maintenance:**
 - **Rehabilitation works – 100% completed.**
 - **Defects Liability Period (6 months) – End of January, 2013.**
 - **The sedimentation/silt ponds - Monitored and cleaned regularly.**
 - **The removed silt material has been stockpiled in a bunded area – located near the Core Yard Area.**

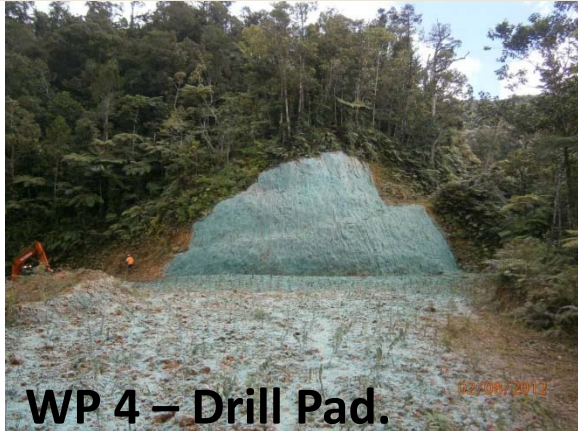
Work Package 4 - Waisoi Area						
Earthworks: <i>(m²)</i>	Drainage: <i>(m)</i>	Geo-textile: <i>(m²)</i>	Hydro-seeding: <i>(m²)</i>	Planting (No.)		
				Ferns:	Shrubs:	Trees:
2,504	251	630	3,830	12,398	-	214
Status: <i>Rehabilitation works have been completed.</i>

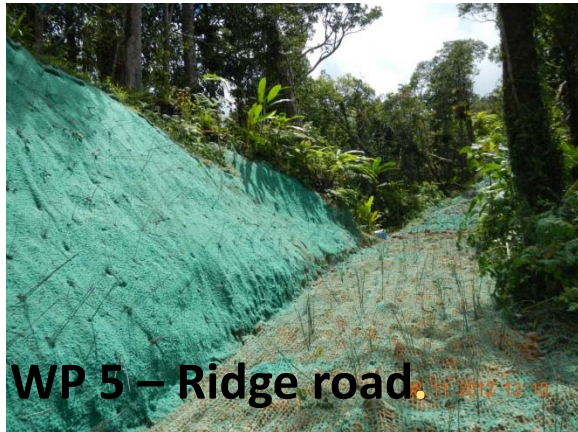
Work Package 5 - Waisoi Area						
Earthworks: <i>(m²)</i>	Drainage: <i>(m)</i>	Geo-textile: <i>(m²)</i>	Hydro-seeding: <i>(m²)</i>	Planting (No.)		
				Ferns:	Shrubs:	Trees:
1,942	121	186	6,203	106,750	-	412
Status: <i>Completed.</i>

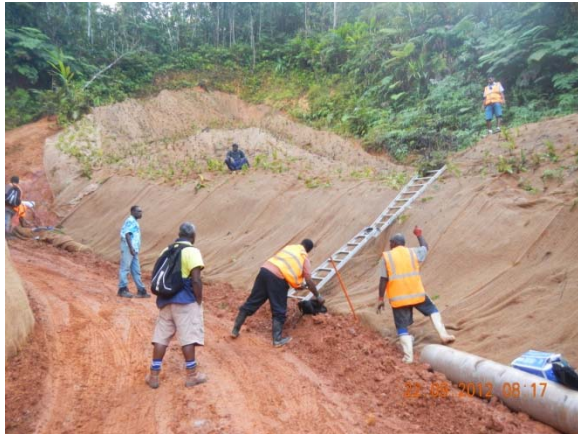
WP 6 – Access Track S10.

Work Package 6 - Waisoi Area						
Earthworks: (m ²)	Drainage: (m)	Geo-textile: (m ²)	Hydro-seeding: (m ²)	Planting (No.)		
				Ferns:	Shrubs:	Trees:
503	16	940	0	11,000	-	0
Status: Completed.

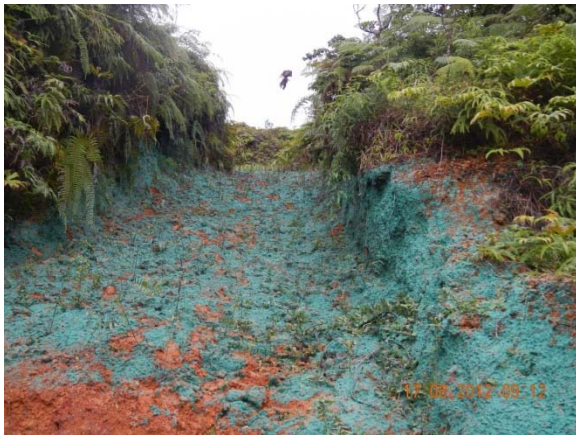
WP 7 – Access Track S7B.

Work Package 7 - Waisoi Area						
Earthworks: (m ²)	Drainage: (m)	Geo-textile: (m ²)	Hydro-seeding: (m ²)	Planting (No.)		
				Ferns:	Shrubs:	Trees:
3,600	203	21	3,792	42,780	-	352
Status: Completed.

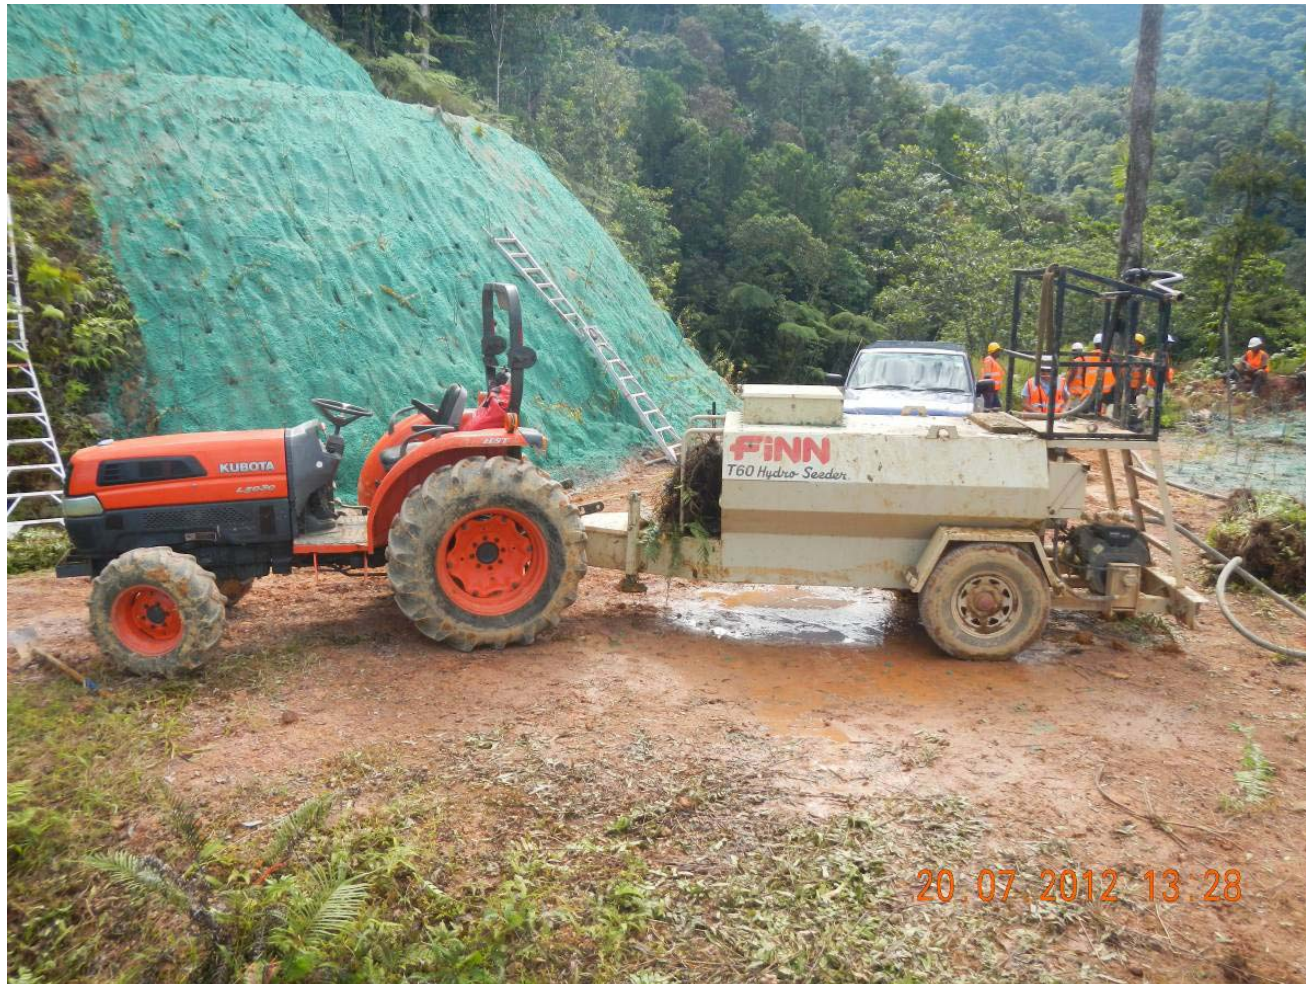
Hydro Seeding

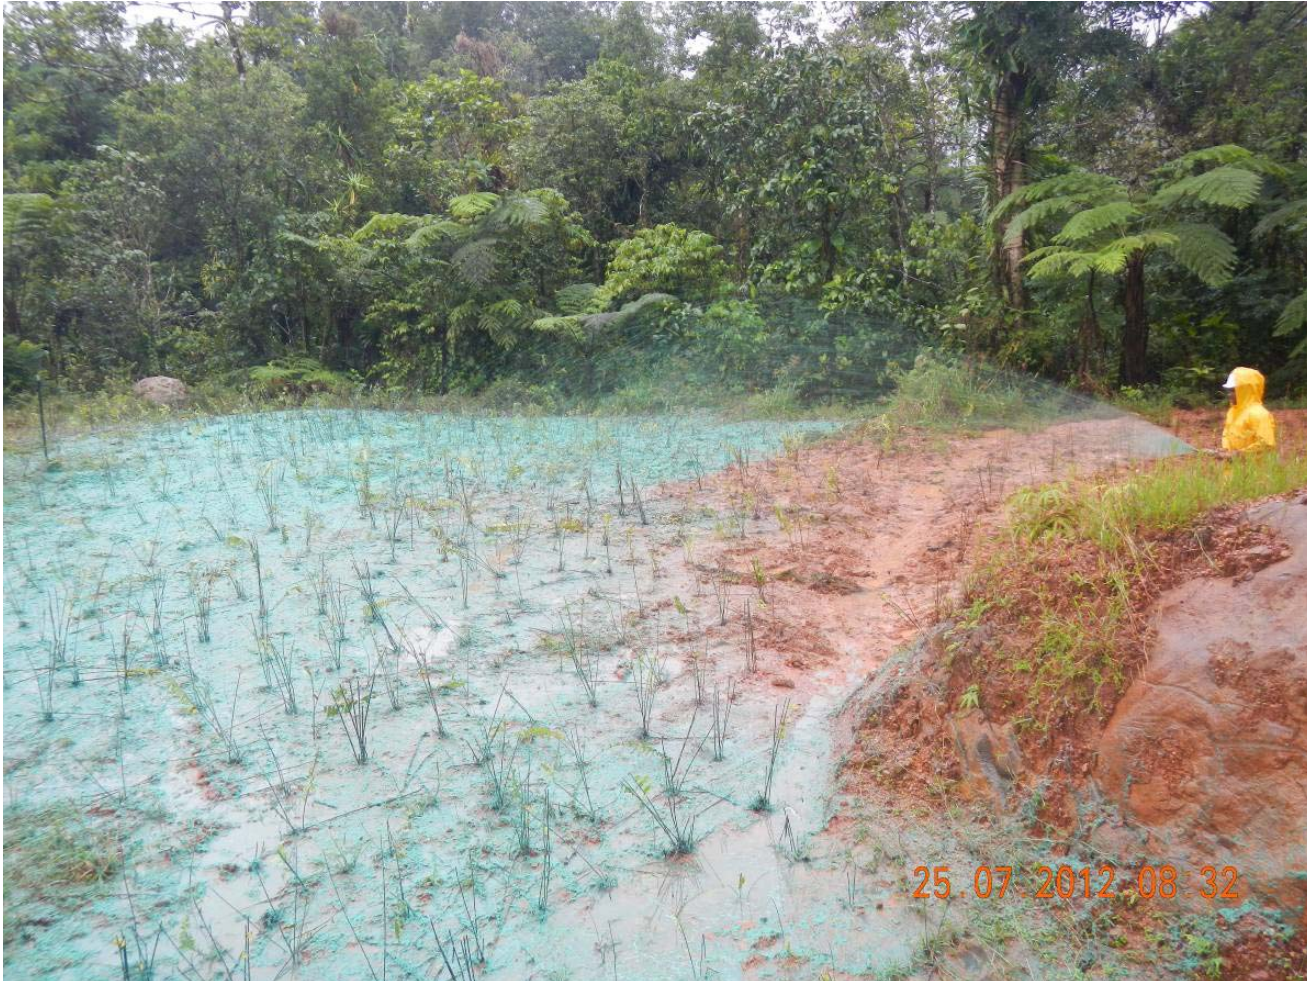
Hydro seeding a drill pad
